DEPARTMENT OF NATURAL RESOURCES
DIVISION OF OIL, GAS AND MINING

RE: Site Inspection, Miracle Rock Mining Company, Body Tody Project, S/015/040, and The Rockland Corporation, Rockland Mine, S/015/085, Emery County, Utah

Date of Inspection: October 30, 2001

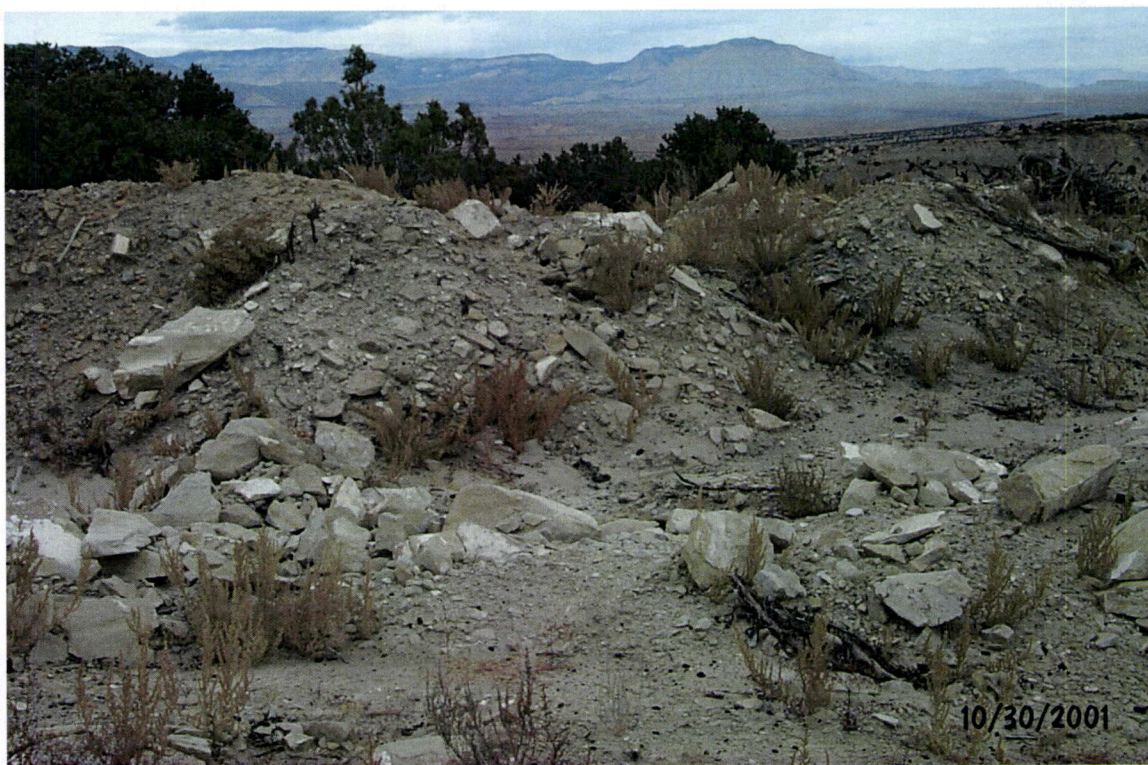
There is a small soil stockpile near the highwall mine, but the only vegetation on it is weeds.

Topsoil pile

The operator needs to be more conscientious about salvaging topsoil, even when there is very little available. I expect some portions of the site will be very difficult to reclaim, and the operator will need all available topsoil. I also recommend the operator seed the small topsoil stockpile near the highwall mine.

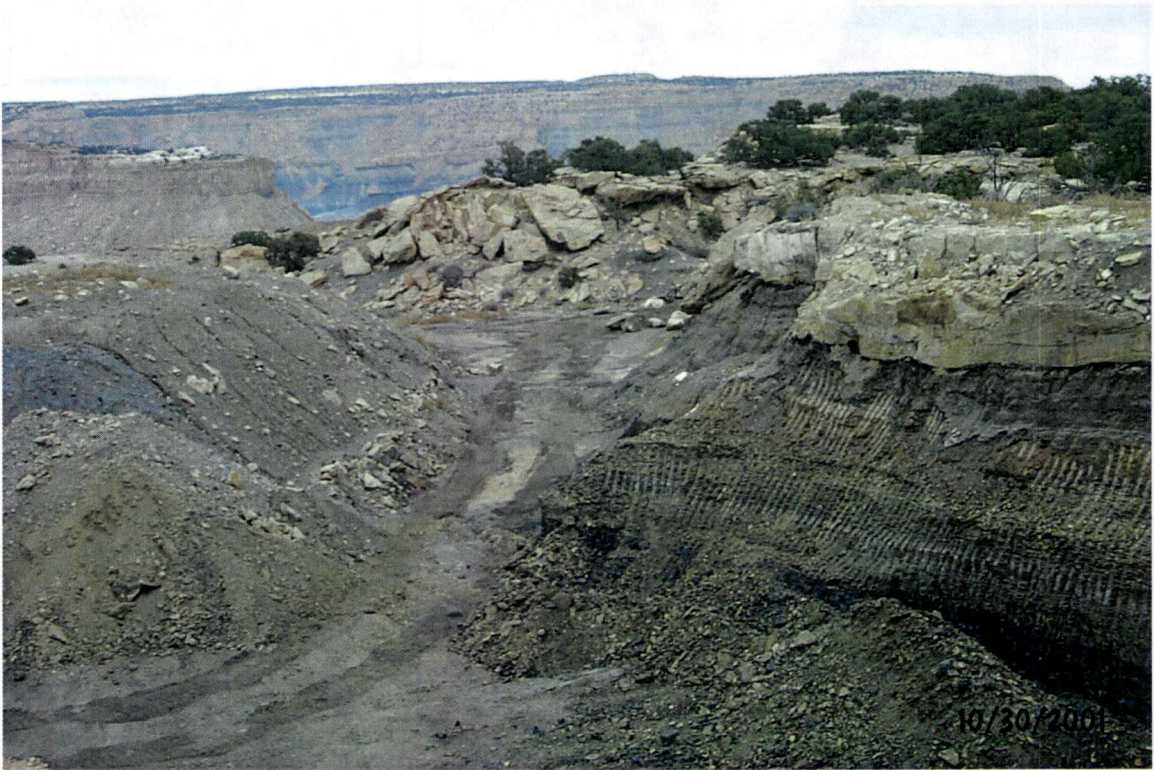
In the middle of the highwall mine pad area is a large pile of waste material consisting mostly of sandstone, shale, and shaley coal. I am concerned about how this waste pile will be reclaimed. My experience is that very little will grow on this type of material, particularly in the arid environment of this area.

Highwall Mine with waste on the left.
